# Reclaiming an erosion prone paddock to a useful 'living haystack'

**Location:** Wharminda

**Region:** Eyre Peninsula, SA

**Issue:** Large blowouts on non-wetting sand dunes had developed over many years and were now in need of urgent rehabilitation and reclamation. Previous attempts had not provided a long-term solution.

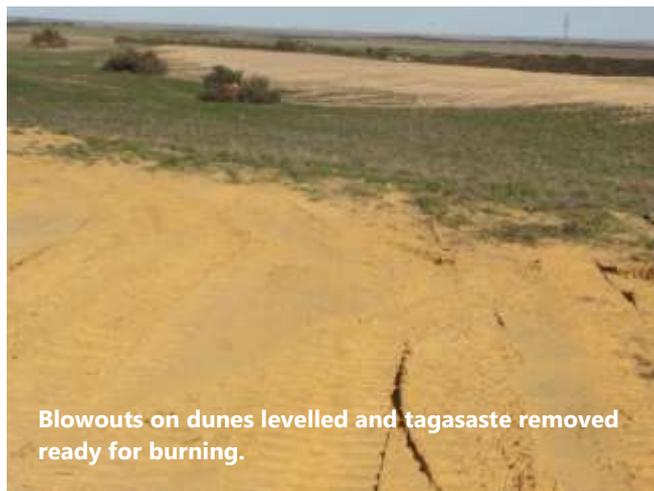
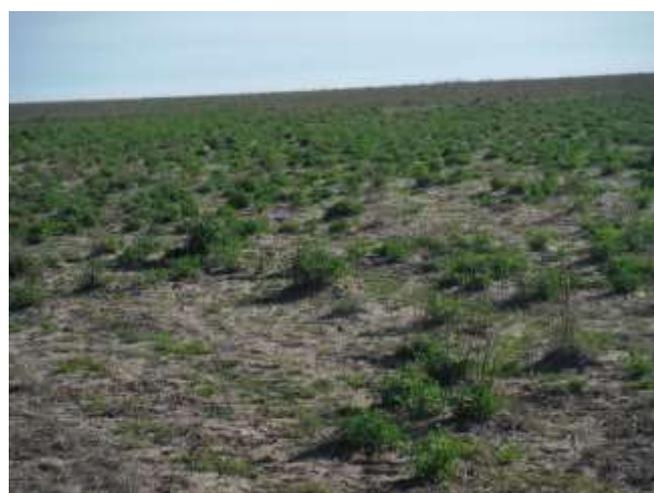
Clay spreading, the final step in reducing the paddocks susceptibility to erosion, was undertaken in autumn 2014. Darren was then able to manage the paddock more effectively and efficiently. As mentioned several times Darren's 'mind is now at ease' when moving stock to that paddock.

The paddock was rested for two year, due to good seasons and ample feed in other paddocks.

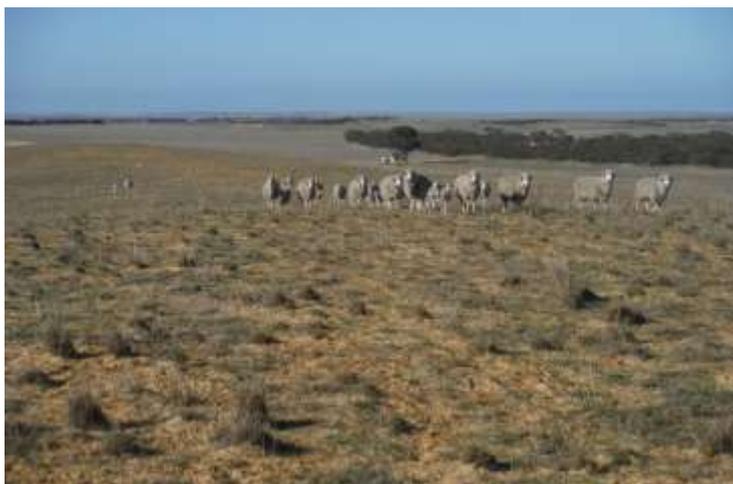
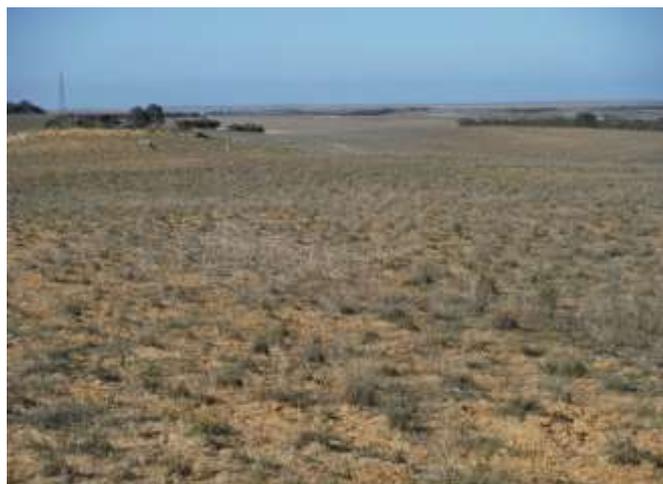
**Cover has been established on blowouts with perennial grasses. Now sheep can graze these areas for short periods of time. This is (almost) a before and after to the photo with Darren standing in the blowout.**
