“Surge Flow Irrigation”

(or Increased Pressure Head Irrigation)

Funded through the
South East Natural Resources Management Board
Irrigation Efficiency Project
September 2008 – June 2010

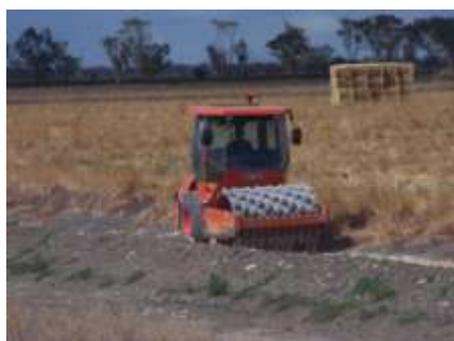
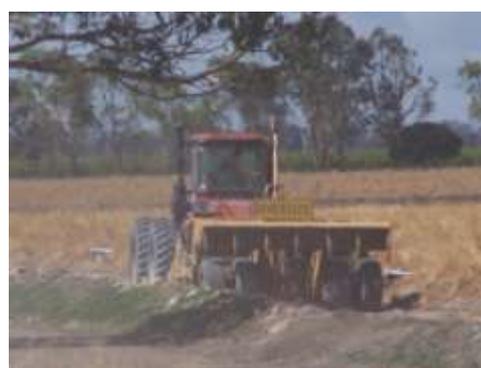
Following surveying of channels to ensure the correct fall, leveling was undertaken, with limestone rubble being used due to its sealing properties. Following this process all channels were compacted using a padfoot roller to reduce losses due to seepage.

Channel height and width was increased so that the system now holds 3.5 megalitres of water at full capacity. We are looking at increasing this further in the future.

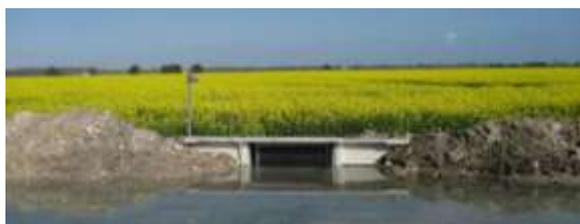
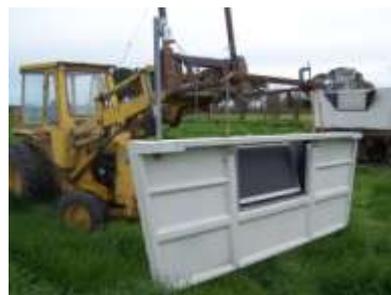
A “Padman Stop” fully sealed gate (see below pictures), with an opening of 4 foot, was installed in each bay opening of the channel.

A “Padman Stop” is a 100% watertight rubber flap set in a concrete structure that makes it easy to automate gravity flow water, thus reducing the loss of water from leaking bay outlets.

These gates are used with a bay sensor, used in sequence with the radio timer which is mounted on each gate and a float system.

The bay sensor is placed strategically down the bay, so that when the water reaches the unit it sends a radio signal to close the watered bay. Each sensor was placed in such a position to allow the end of the bay to be watered without wastage, this position was determined from historical records. In the event of bays being overwatering due to malfunctions, there was a small check bank installed at the end of the paddock to force the water into the next bay, to prevent flow onto roadways and adjoining paddocks, ie wastage.

Once that gate has closed the channel then is allowed to refill before tripping the float at a predetermined level, which then notifies the controller to open the next gate in the sequence.
